Illicit Discharge Detection & Elimination Program

January 24, 2008

Thomas J. DiPietro Jr., South Burlington Stormwater Superintendent
Horace Shaw, South Burlington GIS Technician

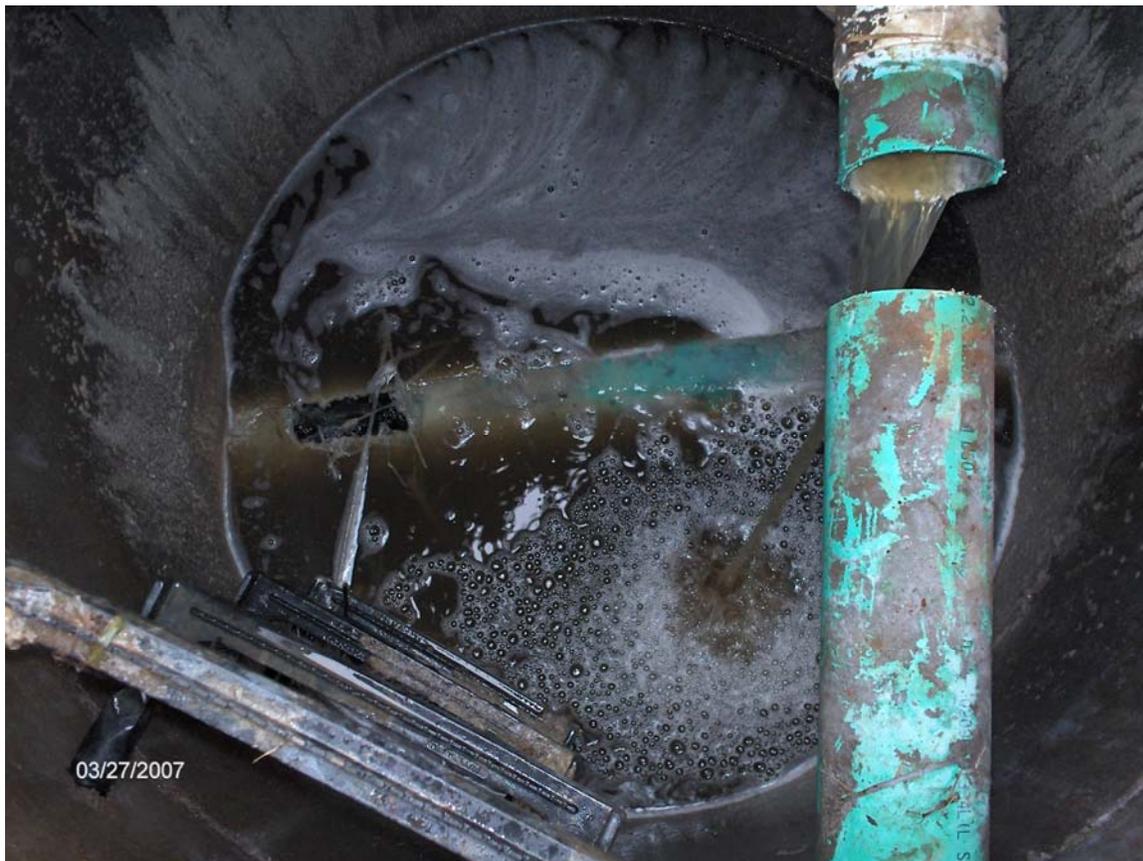
During the course of a regular stream walk and outfall inspection Stormwater Utility (SWU) staff collected samples of the water in Potash Brook near the UVM Miller Research Farm. The samples showed elevated levels of E. Coli. SWU staff contacted the University of Vermont and it was determined that discharge water from the farm's treatment wetland was causing the problem. When the treatment wetland was constructed it was built with the option to discharge directly to the stream, or to the municipal wastewater treatment plant. In order to eliminate the discharge, the wetland's discharge pipe was modified and now effluent from the wetland goes to the wastewater treatment plant.

Modified constructed wetland outfall pipe. Water now flows from the wetland outlet pipe and drops to the bottom of this manhole structure where it flows into the municipal sewer

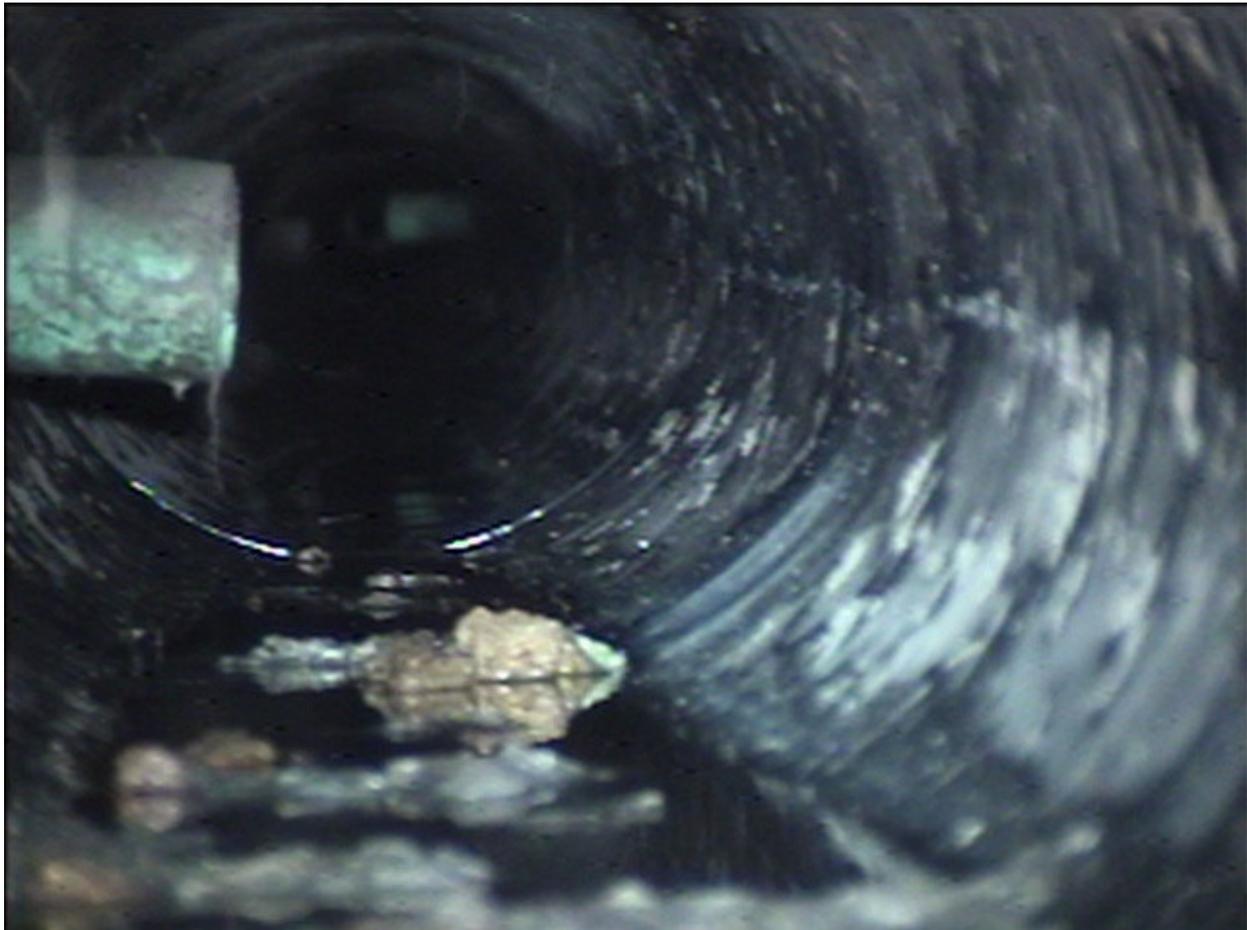
While repairing storm drains on Mill Pond Lane, City Highway Department staff smelled a foul odor coming from one of the storm drains. SWU staff followed up on the incident and discovered that the sanitary wastewater line from one of the homes had been incorrectly connected to the stormwater line instead of the wastewater line. Wastewater from this home had been flowing through the stormwater piping system and directly to Potash Brook for approximately 12 years. CSB immediately called in a contractor to repair the connections. After the repair was made, the SWU conducted follow-up monitoring. The results of this monitoring have not indicated that any additional cross connections exist in the neighborhood.

Sanitary sewer line flowing into the stormwater drainage pipe on Mill Pond Lane

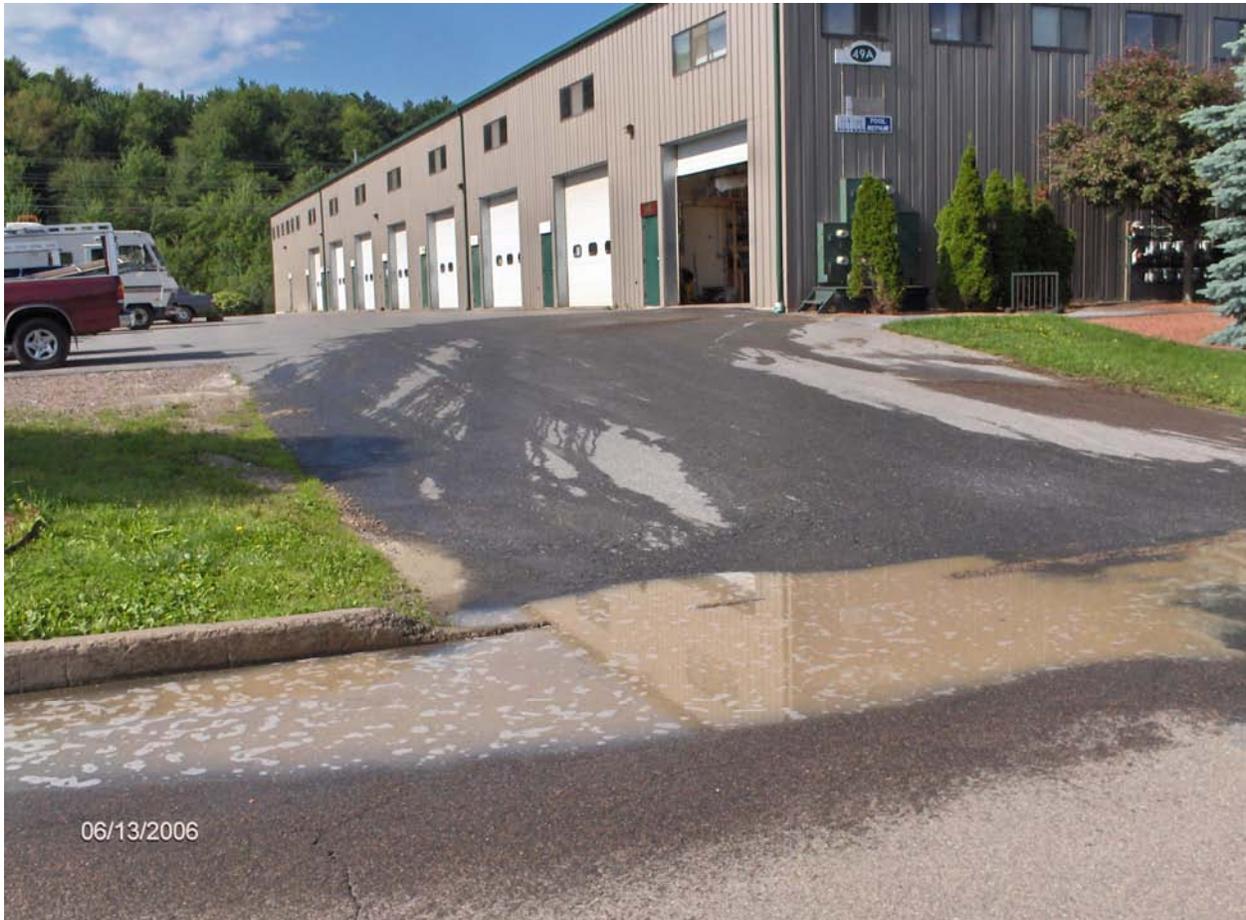
When driving through the Ethan Allen Industrial Park, SWU staff observed obvious signs of vehicle washing. Vehicles were being cleaned on the paved parking lot and the wash water was flowing down the driveway, into the street, and directly into the stormwater system. The stormwater superintendent followed up with the business's owner. The business owner was provided with information about the pollutants contained in vehicle washwater and a letter describing possible penalties if the practice was continued. No additional infractions have been observed.

Vehicle washwater flowing over impervious surfaces and into the City's storm drainage network

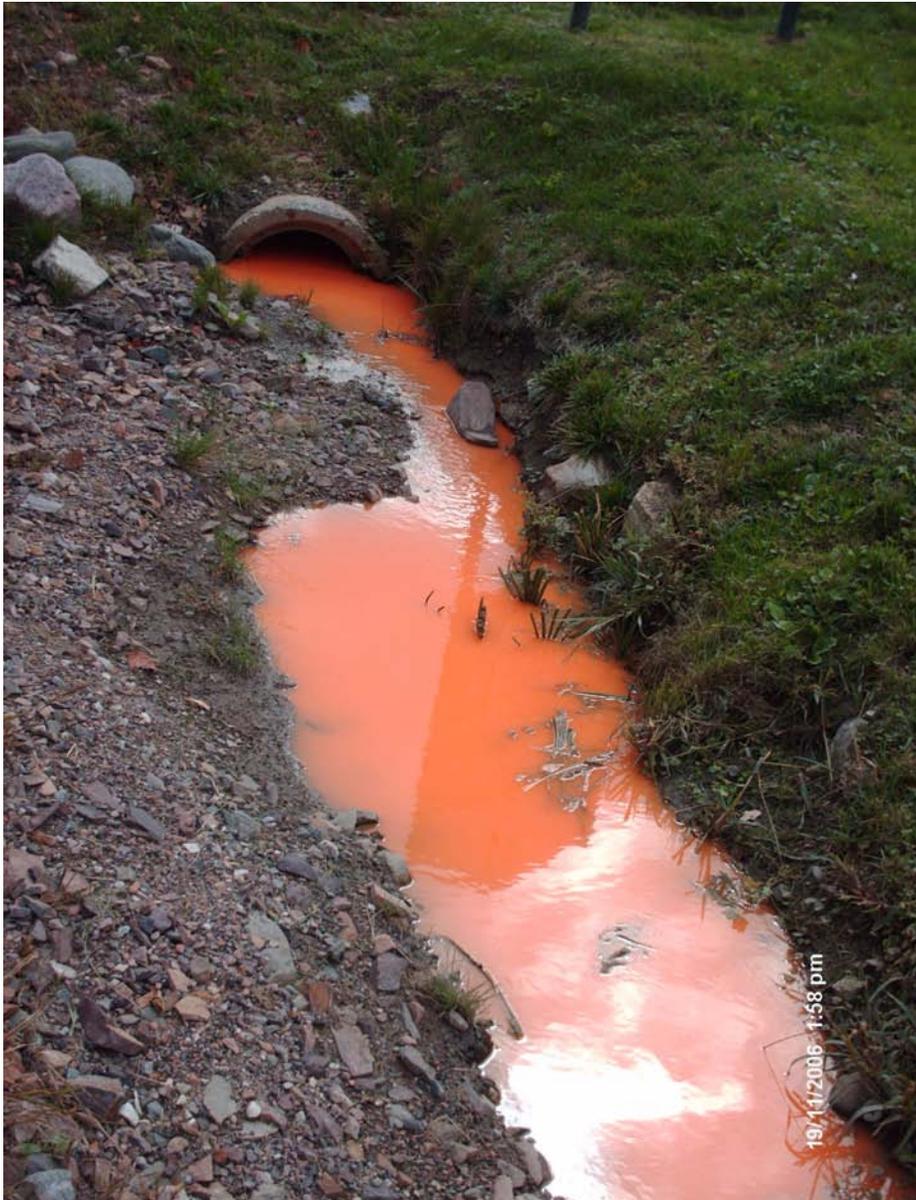
While driving down Spear Street, SWU staff noticed bright orange water in a swale along the side of the road. Following the trail of orange water, SWU discovered where field paint had been dumped into a storm drain near UVM's Gutterson Field House. Discussion with maintenance staff at UVM indicated that excess paint used to line athletic field had been dumped into a storm drain. SWU notified the appropriate individuals at UVM and corrective actions were taken. In addition, UVM followed up with training for maintenance staff to ensure that a discharge of this type will not happen again.

Orange field paint dumped down a storm drain ended up in a road side swale

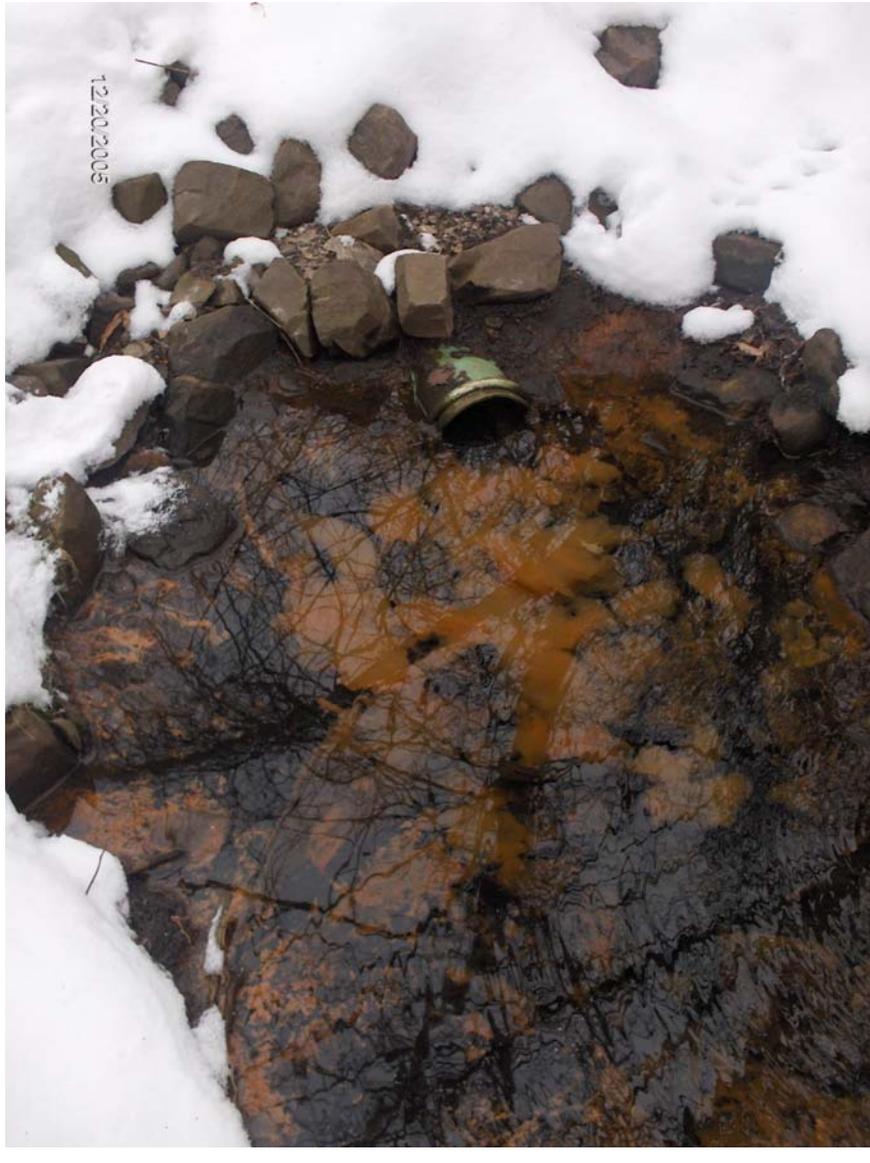
Sampling conducted by SWU staff continually showed elevated E. Coli levels in a stream behind the Grand Union building located at the intersection of Williston and Hinesburg Road. Grand Union allowed SWU staff to conduct dye testing on floor drains in the building and it was determined that one of the floor drains located in the meat department was getting piped directly to the stream. In order to eliminate this discharge, the floor drain was plugged. Subsequent testing has shown a decrease in E. Coli levels in this area.

Floor drain discharging directly to the stream

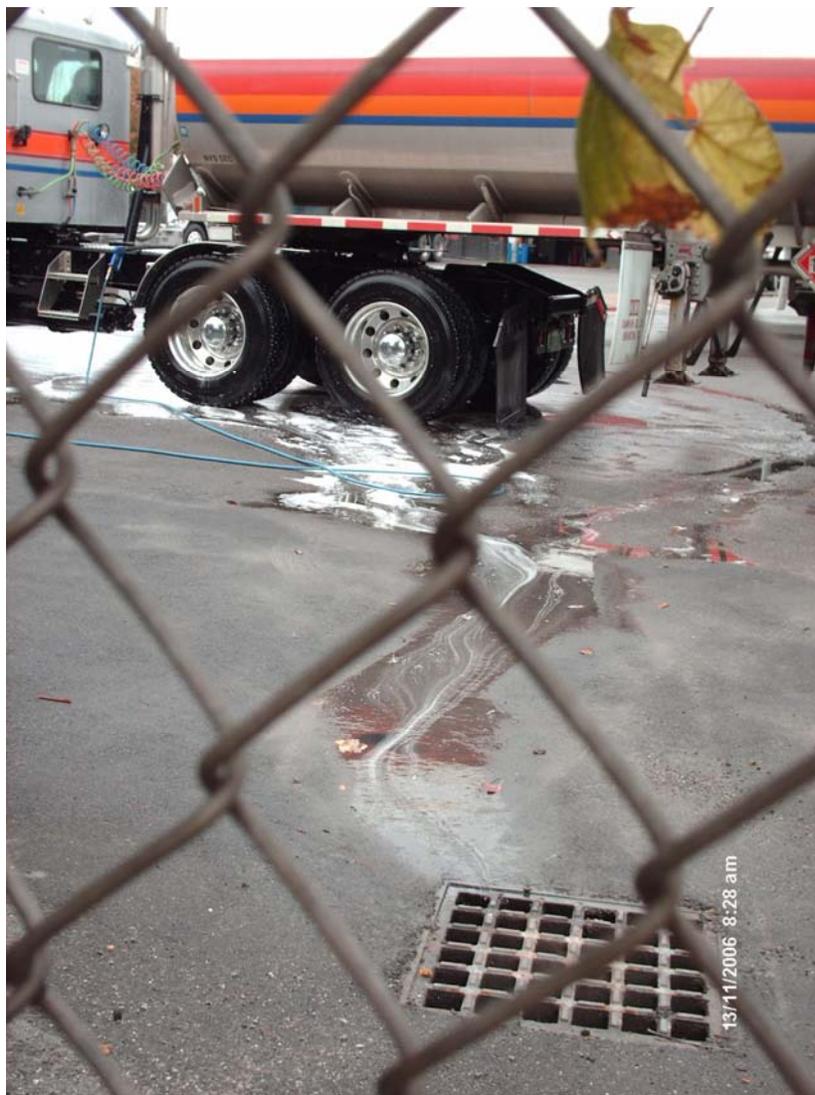
Historic reports of soapy and dirty water in a portion of Potash Brook near Brookwood Drive led SWU staff to investigate upstream inputs to the drainage system. In addition, City staff received calls from residents complaining that a nearby trucking company was washing vehicles and allowing the washwater to flow into a storm drain located on site. In cooperation with the trucking company, SWU staff dye tested the storm drain and determined that the vehicle washwater was in fact entering the stormwater drainage system that eventually discharged into Potash Brook. The trucking company agreed to make major site changes to prevent this discharge from occurring. Washwater is now collected in a storm drain, directed through an oil water separator, and sent to the wastewater treatment plant. A small berm prevents additional runoff from the parking area from entering the storm drain.

Vehicle washwater entering a storm drain

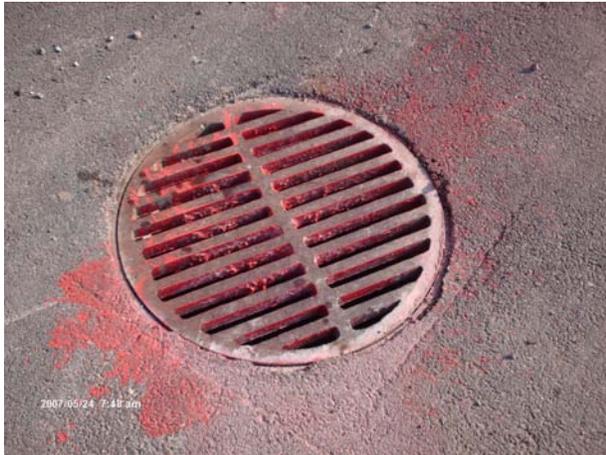
SWU staff received a call from the construction inspector on the Kennedy Drive reconstruction project describing a red discharge flowing into the wetland adjacent to the construction site. SWU traced the red discharge to a storm drain located near the maintenance entrance at the South Burlington High School. Discussions with school representatives determined that school maintenance staff had dumped old field paint down the storm drain. At the time of the spill, measures were taken to reduce the amount of red paint reaching the wetland. After the incident, the school district conducted additional training for maintenance personnel. In addition, SWU staff placed metal “No Dumping” labels on all the storm drains located at the public schools.

Storm drain where old field paint was dumped. This storm drain leads to a nearby wetland.

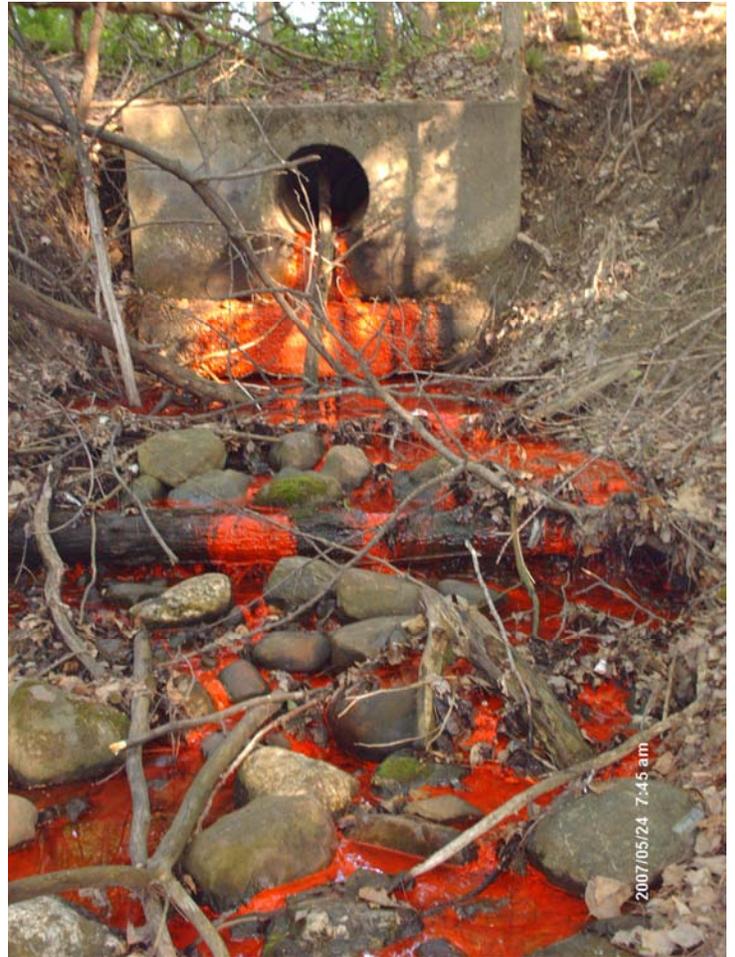
Storm drain outfall pipe. Field paint dumped down the storm drain flowed down this drainage swale and into the wetland

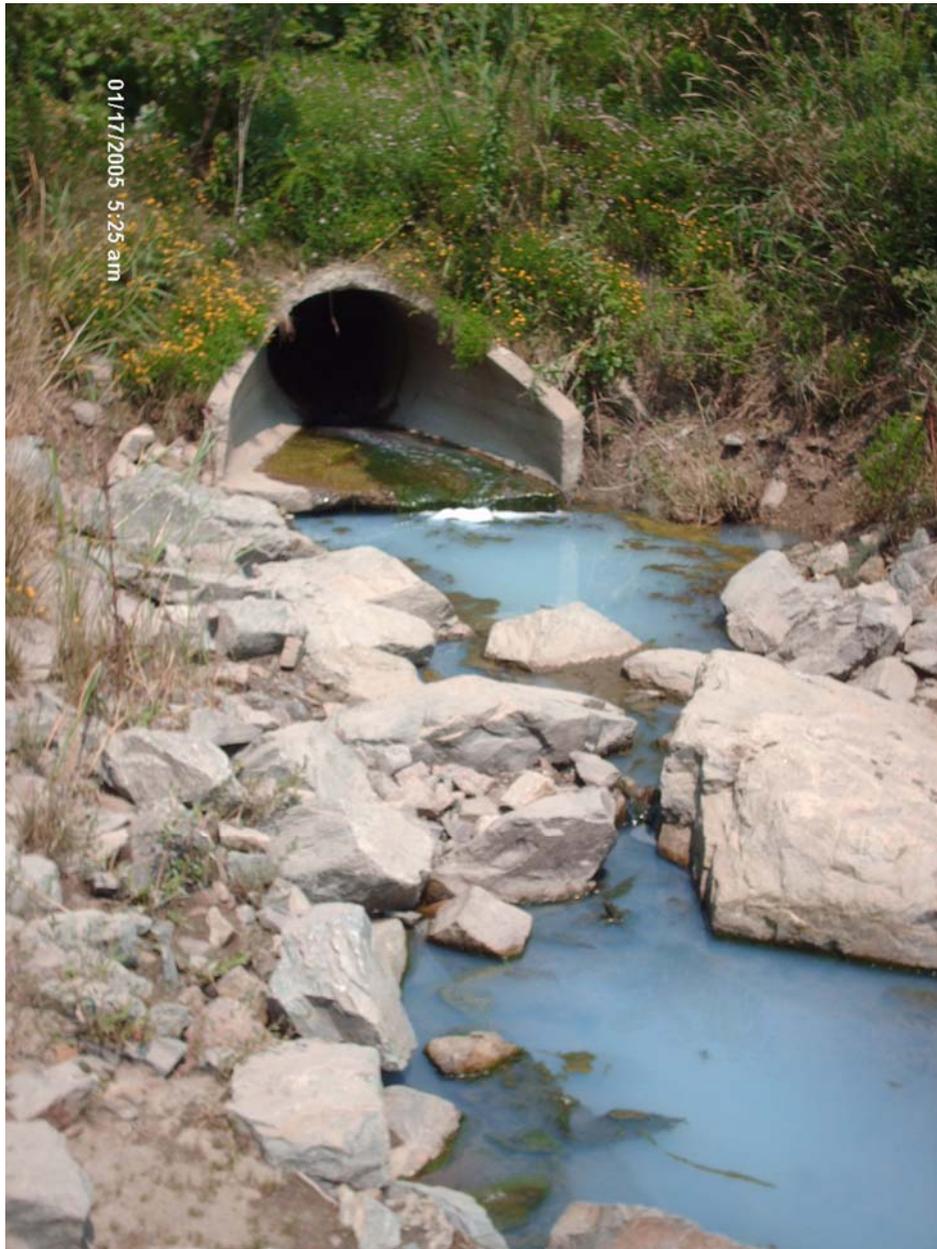
While inspecting stormwater infrastructure, SWU staff noticed a blue discharge entering the UVM stormwater treatment pond near the Sheraton hotel. SWU staff contacted representatives at UVM and attempted to find the source of the blue discoloration. A definitive source for the discharge was never discovered.

Blue discharge into UVM stormwater pond

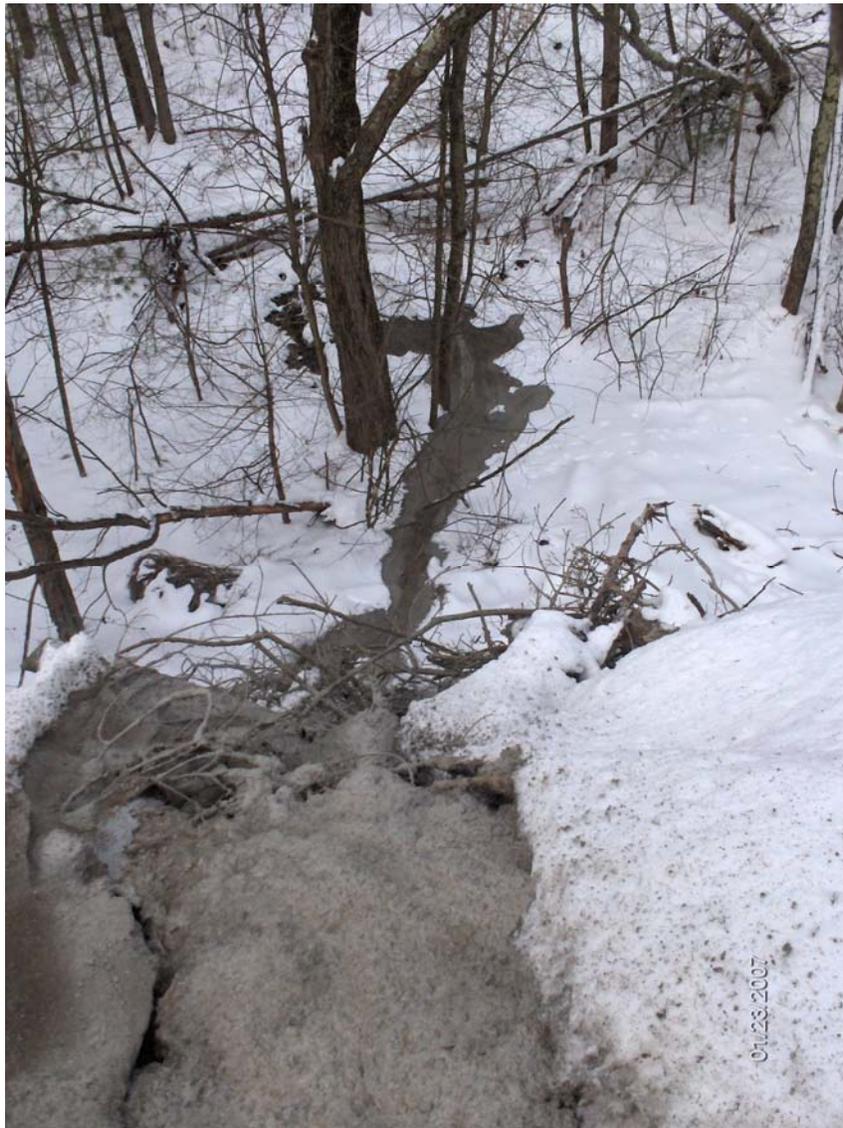
During a stream walk associated with regularly planned outfall inspections, SWU staff observed a trail of concrete leading from the top of a slope down towards Potash Brook. The facility at the top of the slope manufactured concrete vaults for funerals. The concrete supplier would arrive in a ready mix truck a few times a week and pour concrete into molds at the facility. The contractor would then back his truck up to the edge of the parking lot and wash the cement out of the back of the truck. This prevented hardened concrete from falling off the truck as he drove back to the plant. Stormwater staff explained the problem with this practice to the business owner and contacted the concrete company to advise them to discontinue this practice. No additional incidents have been observed.

Workers had been cleaning off a cement truck and allowing the material to flow down the bank towards Potash Brook

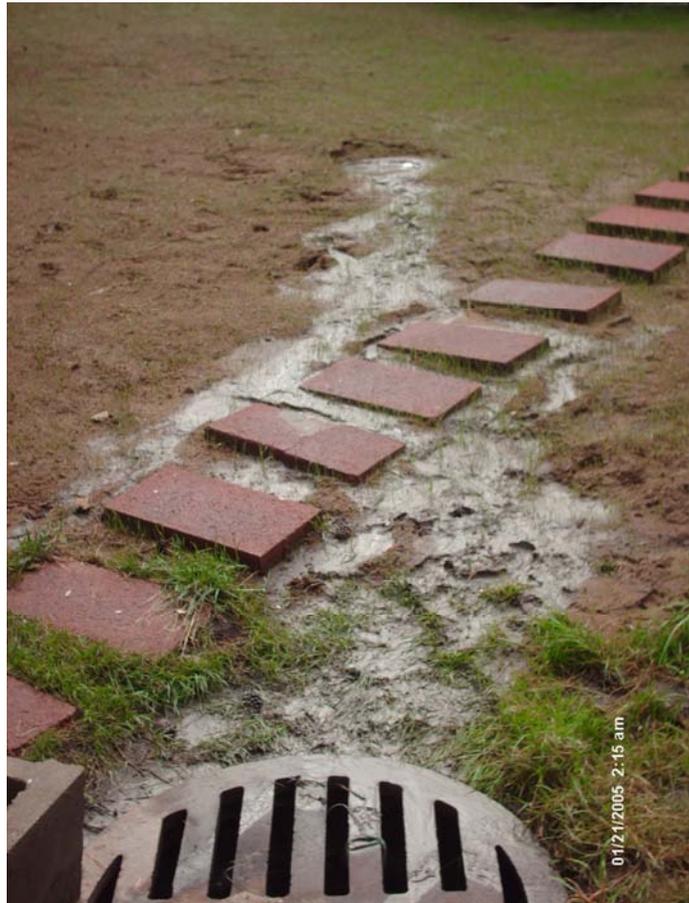
A resident called the Department of Public Works in South Burlington to complain about water bubbling up in his lawn. The cause of this water could not immediately be identified. The bubbling would occur intermittently and not necessarily when the nearby wastewater pump station was in operation. In addition, numerous foundation drains were tied into the nearby storm drain and were also suspected to be the cause of this discharge. Because it was an older neighborhood, maps of the buried infrastructure were unreliable. After speaking with nearby residents, dye testing the pump station and dye testing toilets of the nearby homes, City staff decided to excavate in order to determine what was causing the discharge. It was discovered that the 2" force main from the nearby pump station ran through this yard and had cracked. When the pump turned on, it caused the water to bubble to the surface. A piece of fabric was on the pipe near the crack and this could possibly have plugged the hole at times. This would explain why the bubbling did not correlate to when the pump station turned on. The force main was repaired and the area was backfilled, seeded, and mulched. No additional discharges have been observed.

A cracked 2" sanitary sewer force main was causing wastewater to bubble to the ground surface and flow into a nearby storm drain.

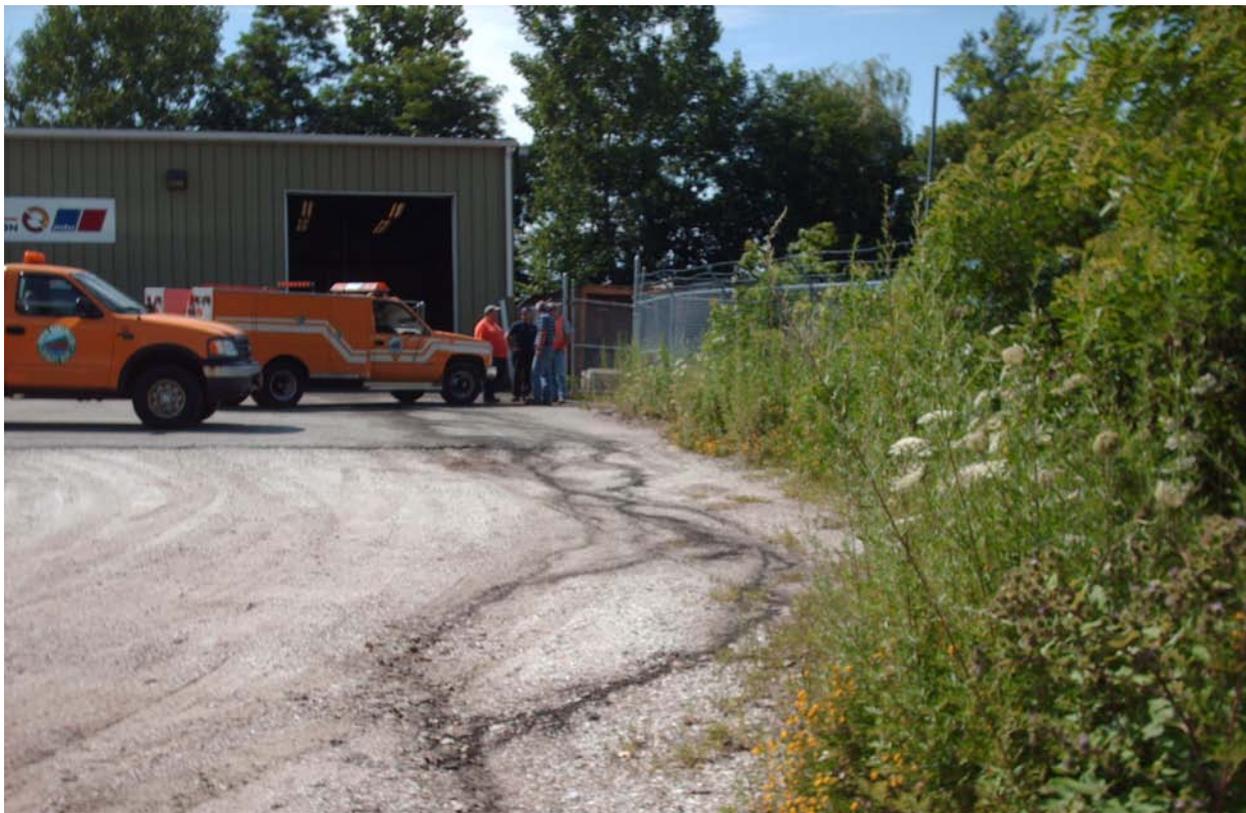
The South Burlington City office received a call from a former employee at the Atlantic Detroit facility located at Berard Drive complaining that the wastewater leach field had been tampered with. No evidence of this could be observed, however, while on site City staff observed a trail of oil leaving the garage and leading towards the Winooski River. Discussions with staff at Atlantic Detroit revealed that someone had washed a truck engine outside and allowed the washwater to flow off the site. SWU staff provided the garage workers with information about the proper way to clean engines, how to handle waste oil, and other garage best management practices (BMPs). A letter detailing the incident was sent to the facility recommending training and other BMPS.

Maintenance garage staff washed an engine outside and allowed the washwater to flow off the site.
