# ENGLESBY BROOK FLOW RESTORATION PLAN

September 30, 2016

Julie Moore, P.E. Stone Environmental, Inc. 535 Stone Cutters Way

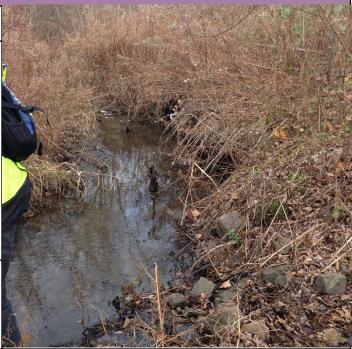
Modify existing treatment wetland system to provide detention storage in addition to water quality functions.

Limited available space for additional storage without relocating stream channel; concept would result in some loss of WQ function.

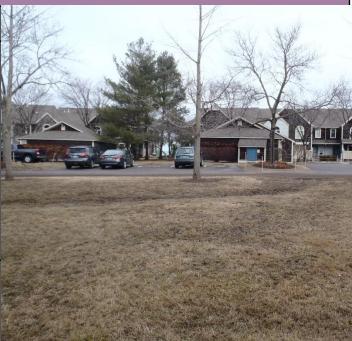
Following EFA, runoff from a portion of the parking lot is diverted using speed bump to existing green space where it flows overland to the storm sewer system. Detention area could be constructed in green space to control peak flows; additional impervious areas (roofs and parking) could be redirected to improved stormwater practice.

Notes/Feasibility: Existing practice has limited effectiveness.

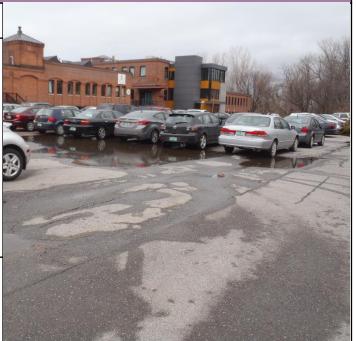
Currently stormwater runoff from parking is being diverted to rock-lined swale and conveyed to Englesby Brook. Evidence of erosion in stone-lined channel. Underground storage could be constructed at the northeast corner of the lot. Some runoff from parking lot will be captured and treated in stormwater facility planned for Champlain Parkway.

Field inspection found that it would be extremely challenging to convey sufficient runoff volume to the proposed facility.

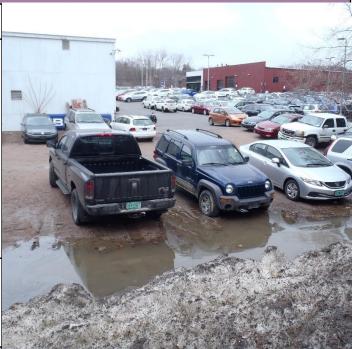
Underground storage could be installed along back edge of Burlington Subaru dealership to manage parking lot runoff.

As shown in photo, area is currently used for vehicle parking/storage, therefore any practice would need to be

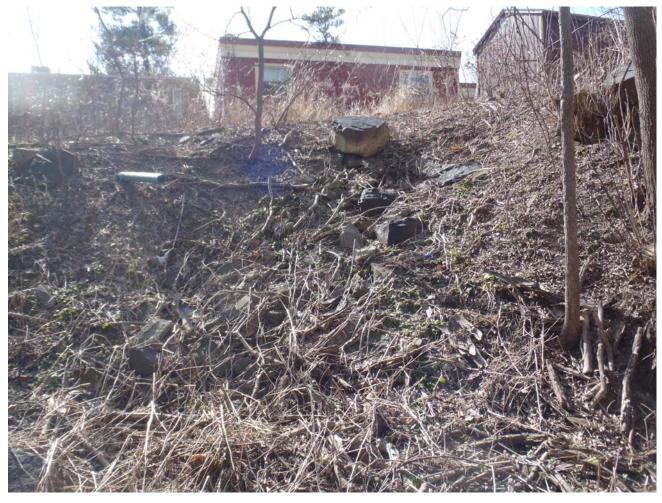
Photo 1: Presumed Location of Natural Drainage Swale and Unknown Subsurface Drainage Outlet

#### 1-0337, Howard Mental Health Services, 300 Flynn Ave.

Permit covers the discharge of roof drainage via "stone lined ditch in natural drainage swale" to Englesby Brook; parking lot runoff does not appear to be regulated under the permit. During the site visit we found that the stone lined ditch is not well defined. The majority of flow leaving the site and discharging to Englesby Brook appears to occur via subsurface drain pipes not included in the permit; four outfalls were identified during the site visit that are not included in the City's stormwater GIS layer, including one of which appears to divert water directly from Pine Street. In order to bring this facility into compliance with its existing permit, the stone lined ditch would need to be improved. In addition, the source of the water draining to each of the subsurface drains should be confirmed. As part of the Englesby Brook Flow Restoration Plan (FRP), a potential retrofit was identified for managing runoff from parking lots draining to the existing green space behind 300 Flynn Ave.

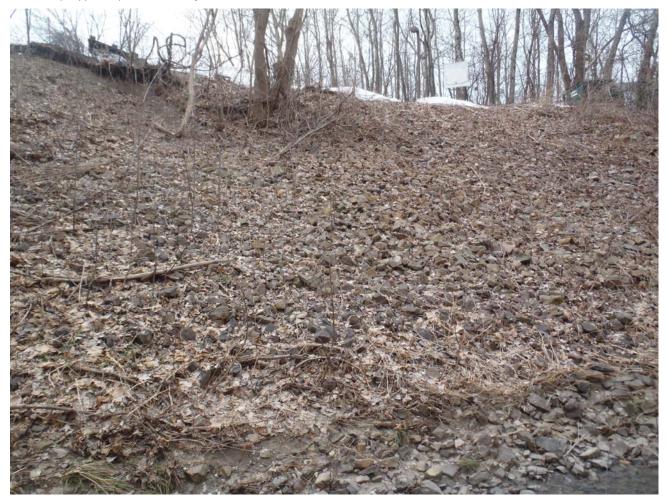
Photo 2: Rip-rapped Slope Behind 288 Flynn Ave

#### 1-1087, Flynn Ave Coop Housing, 288 Flynn Ave

Permit covers the discharge of stormwater runoff from roofs and paved parking lots following treatment "via grass-lined swales, through rip-rapped areas at the top of bank of Englesby Ravine, and via overland flow across vegetated terrain..." During the site visit we found that there are grass-lined to the north of the apartment complex which appear to convey stormwater runoff to rip-rapped areas that lead down to the ravine. We also noted during our site visit that the parking lot catch basin indicated in the City's stormwater GIS layer does not exist. This site was generally found to be in compliance with its permit. As part of the Englesby Brook FRP, a significant potential retrofit was identified for in the green space immediately to the west of 288 Flynn Ave. and to the east of the proposed Champlain Parkway alignment.

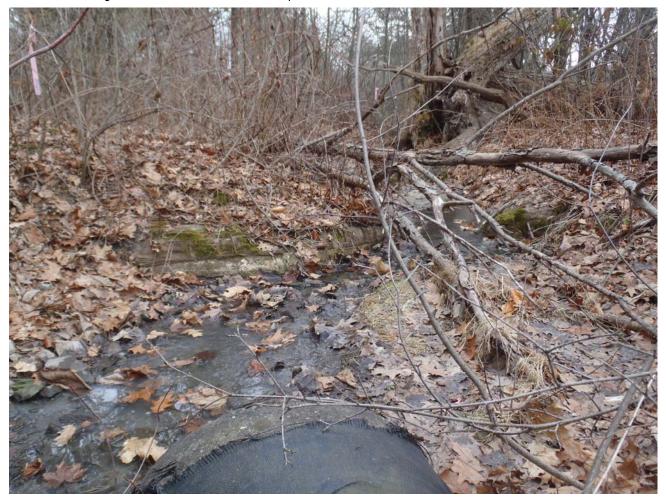
Photo 3: Looking Downstream from the 15" Concrete Pipe Outfall

#### 2-0789, Overlake Properties, 545 Prospect St

Permit covers the discharge of stormwater runoff from paved road and parking lots after treatment by "passage through trap catch basins" to a stone bed and "approximately 1000 feet overland flow through wooded area and grassed drainage swale to the stream." During the site visit we observed that sediment levels in the catch basin were below the invert of the outlet pipe, but that the outlet lacked a trap or hood. In addition, we observed a PVC pipe passing through the basin (not draining into). The stone bed noted in the permit could not be located. A 15" concrete pipe and 6" PVC pipe were both located approximately 100 feet southeast of Prospect St, which discharged into a small wetland area (see Photo 3). We followed the outflow from the wetland area for a considerable distance but could not see where it connected to the stream; a portion of the flow appeared to cross Prospect Pkwy. In order to bring this facility into compliance with its existing permit, a trap or hood would need to be fitted onto the catch basin outlet and a stone bed or other

energy dissipation measures added at the outlet. In addition, it would also be prudent to determine the source of the water passing through the catch basin in the PVC pipe in order to guard against a potential illicit discharge were it to carry something other than stormwater. As part of the Englesby Brook FRP, a potential retrofit was identified for managing runoff in the green space at the southern end of the parcel.

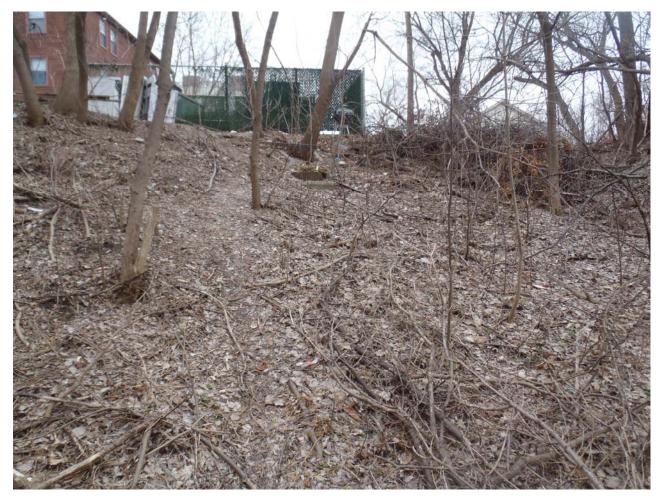
Photo 4: Looking East toward Dumpster Cage and Probable Septic Tank Location

#### 2-0999, Champlain Apartments, 817 Pine St

Permit covers the discharge of stormwater runoff from paved parking areas after "passage through trap catch basins and a 1500 gallon septic tank in series" before being piped directly to the city stormwater system. During our site visit we observed that sediment in all three parking lot catch basins has accumulated above the invert of the outlet pipe. No access manholes (or similar) for the septic tank were observed; the septic tank may be located under the dumpster cage in the south west corner of the parking lot (see Photo 4). The catch basin indicated in the City's stormwater GIS layer in the green space/courtyard area near the building could not be located. In order to bring this facility into compliance with its existing permit, the catch basins would need to be serviced and a trap or hood would fitted onto each of the outlets. In addition, the septic tank should be formally located and likely serviced. As part of the Englesby Brook FRP, a potential retrofit was identified along/underneath the western edge of the parking lot.

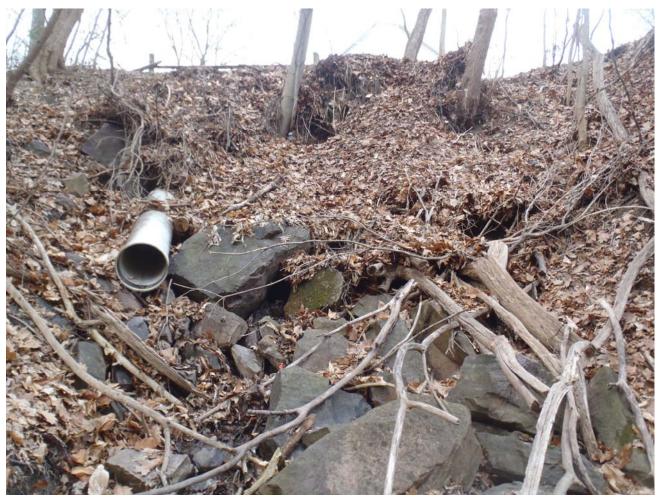
Photo 5: Large Stone Rip-Rap at Outfall

#### 2-1052, Crescent Terrace

Permit covers the discharge of stormwater runoff from the paved roads and driveways, roofs and natural terrain, via overland flow across "grassed and/or vegetated terrain to a catch basin and rip-rapped outfall, prior to discharge to an unnamed tributary..." During our site visit we observed that sediment levels in the three catch basins indicated in the City's stormwater GIS layer were below the invert of the outlet pipes. The vegetated terrain and rip-rapped outfall were observed as described in the permit. This site was generally found to be in compliance with its permit. No specific retrofit for this site is currently contemplated at part of the Englesby Brook FRP, however this is a part of a neighborhood generally being evaluated for targeted disconnection.
