Stream Buffer Report

December 28, 2007

South Burlington
Stormwater Utility

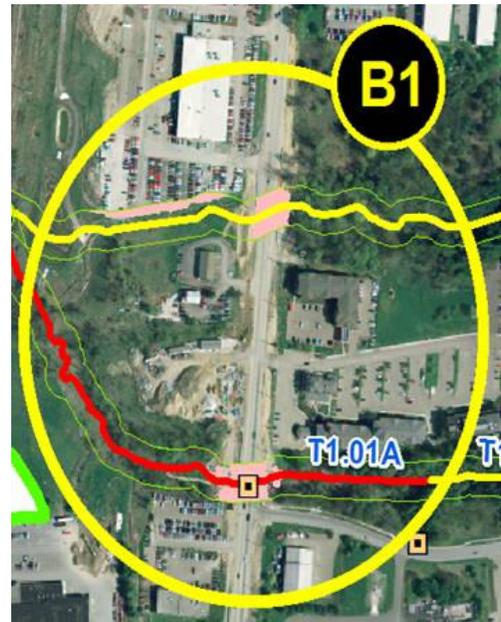
There have been 4 areas of concern identified in the Bartlett Brook watershed. The first area (B1) is located near the bottom of the watershed. The two main branches of the brook are carried underneath Shelburne Road (Rt. 7) by large culverts. The northern culvert is 60 inches in diameter and carries the main stem of the brook for 606 feet. The southern culvert has a 64 inch diameter and carries the stream for 173 feet. As would be expected at a road crossing, there is significant encroachment of impervious surface area into the stream buffer. In addition, SGA data for the area surrounding the southern culvert classified the reach as “extremely sensitive”.

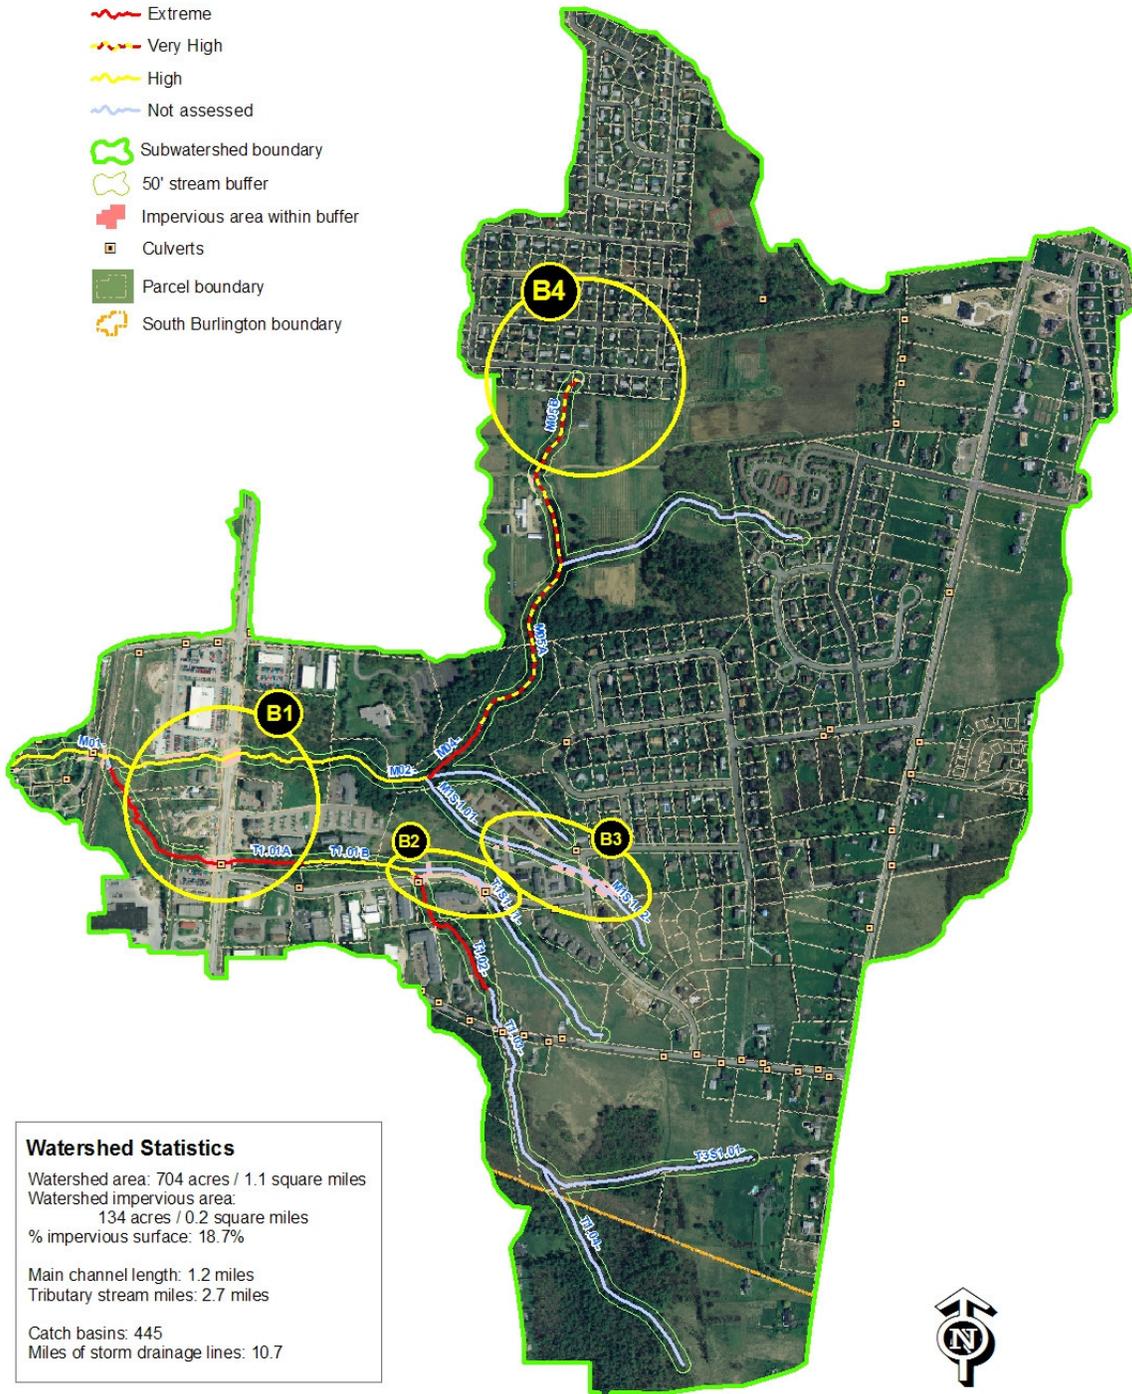
Bartlett Brook Subwatershed

The fourth area of concern (B4) identified in Bartlett Brook is located in the Laurel Hill South neighborhood. Although it is not shown on the map, Bartlett Brook runs along the UVM farm and City bike path before entering into the catch basin and piping system underneath Sebring Road. The stream travels through the piping system for approximately 1,000 feet before it daylights to the south of the Laurel Hill neighborhood and onto the UVM Horticultural Farm. SGA data collected for the portion of the Brook located south of the Laurel Hill neighborhood classifies its sensitivity as “very high”. In addition, there are in-stream ponds that UVM uses for irrigation located within this reach. Although these did not appear in our analysis of impervious area, they are obviously within the protected stream buffer.

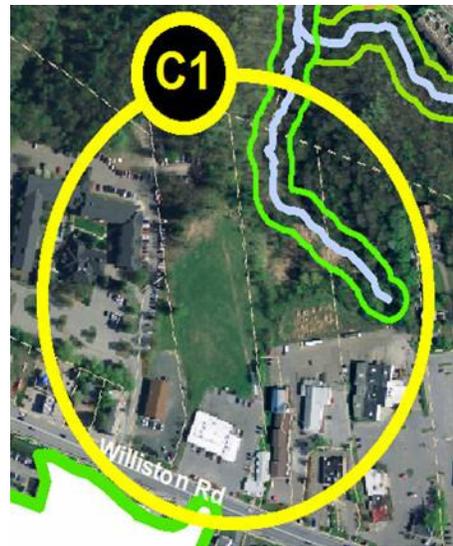
Two locations were identified as areas of concern in the Centennial Brook watershed. Although there are currently no encroachments into the 50' stream buffer in area C1, this location has been identified due to the likelihood of future development. In this location, Centennial Brook approaches Williston Road and the surrounding commercial businesses. An increase of impervious area north of Williston Road would approach the stream, and this development is likely to occur in the near future. Currently, the stormwater that flows to this reach from Williston Road and the surrounding businesses receives no treatment. Although an assessment of this reach has not yet been conducted by ANR, visual observation by City staff indicates that problems exist and treatment of stormwater runoff is needed in this area.

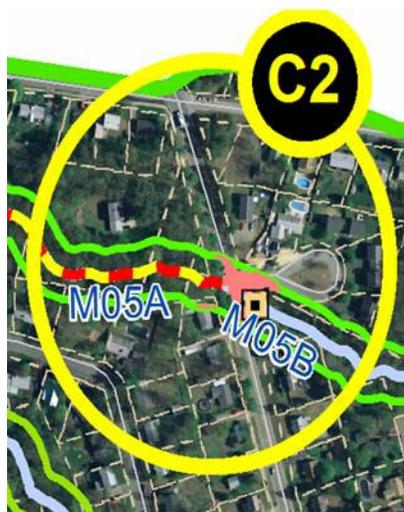
The second area of concern (C2) is located near the intersection of Airport Parkway and Picard Circle. At this location, Centennial Brook enters a 36 inch corrugated metal culvert for approximately 80 feet. As would be expected at a road crossing, there is significant encroachment of impervious surface area into the stream buffer. Downstream of this road crossing the SGA data provided by ANR shows that the stream has a sensitivity rating of “very high”.

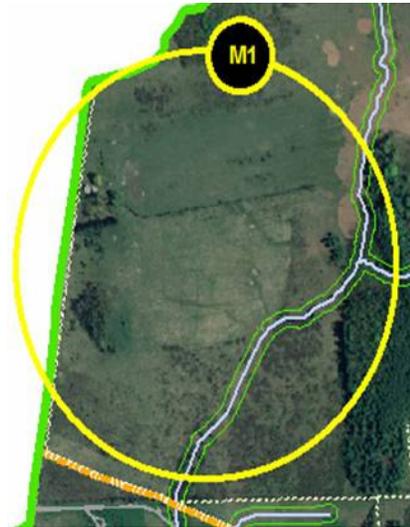
Area M1 was identified as needing special attention in the future. Construction of the South Village neighborhood is currently underway in this area. The plans show that an appropriate buffer will be maintained around the stream, with the notable exception of two areas where a new road will cross the brook.

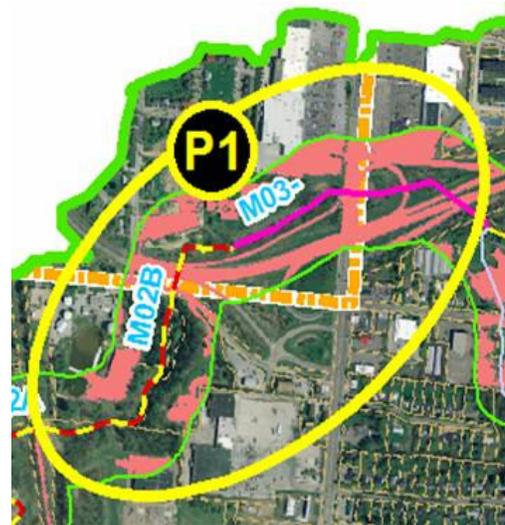
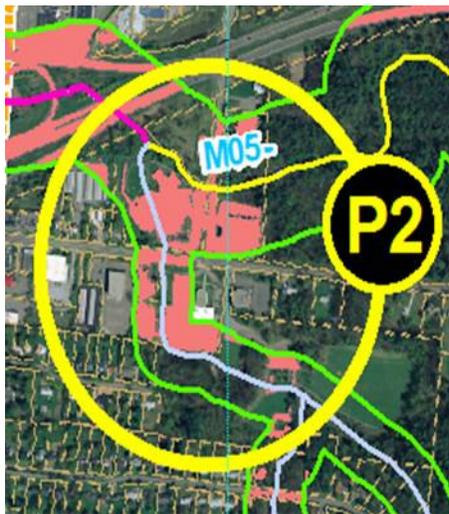
Eight areas with significant buffer impacts were identified in Potash Brook. The first area (P1) is located near the mouth of the brook, along the Shelburne Road (Rt. 7) and I-189 intersection. In this area, the brook flows through culverts beneath Shelburne Road and the I-189 turning ramps. The brook also flows near a commercial plaza with a large amount of impervious area. Steep banks lead from the buildings and parking area down to the brook in the northern section of area P1. In addition, the sensitivity of the stream in this area has been rated as "extreme" and "very high".
