Scoping Study

Kimball Avenue / Marshall Avenue Muddy Brook Culvert Replacement VTrans Project STP MM18(3) South Burlington / Williston, Vermont

Prepared for:
City of South Burlington, Vermont
Town of Williston, Vermont

Prepared by:
Hoyle, Tanner
& Associates, Inc.
www.hoyletanner.com

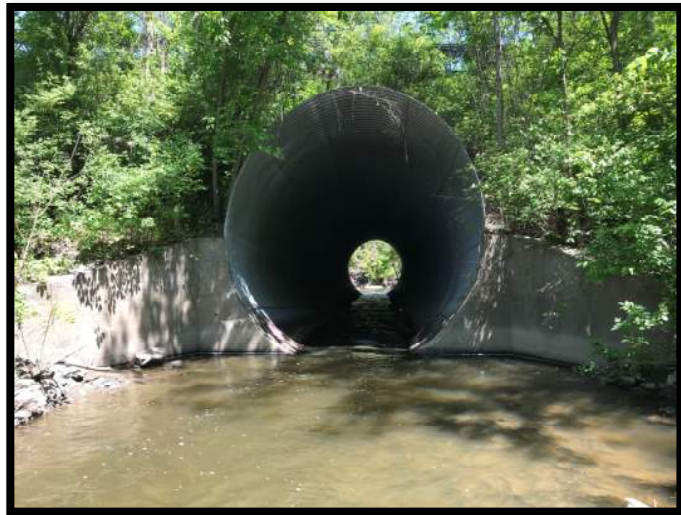
Downstream Culvert Elevation

The original construction of the existing 15-foot diameter corrugated metal pipe culvert was completed in 1986. The culvert is failing due to a severe corrosion at the invert (bottom portion of the pipe) resulting in localized buckling at several locations, and fractured plate connections along the walls of the pipe. Currently, a 150'-span temporary bridge (installed in 2017) conveys traffic over the failing culvert. The roadway embankment slopes are retained concrete "cradle walls" at the culvert inlet and outlet

with top of wall elevations approximately at half the pipe diameter. Above the walls, the embankment slopes around the culvert to the cradle walls allowing the upper section of the culvert pipe to project from the embankment slope. The roadway embankments approaching the crossing are armored with stone fill and are vegetated.

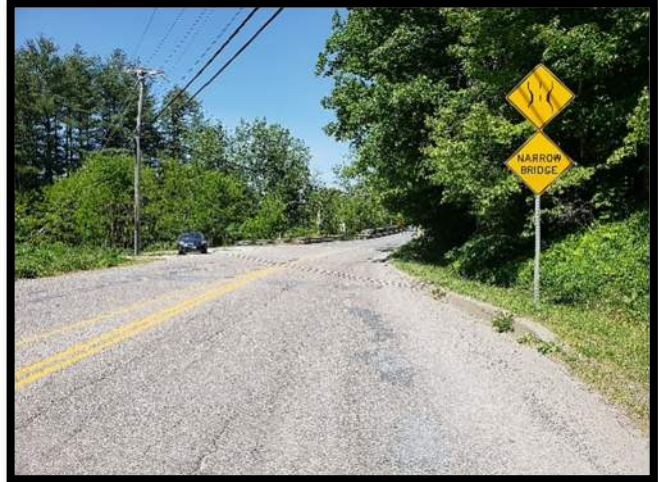
Pavement Condition East of Bridge

The pavement condition west of the crossing is in poor condition with surface delamination between the top two pavement courses. East of the bridge the pavement is also in poor condition with longitudinal and transverse cracking and minor wheel rutting.

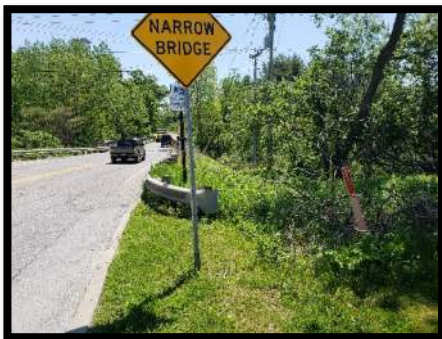
Typical Guardrail and Side Slope

Roadway side slopes along the eastbound lane transition from flat foreslopes west of the crossing to steep 2H:1V slopes through the crossing before returning to relatively flat slopes at the drive east of the crossing. Roadway side slopes along the westbound lane transition from flat foreslopes west of the crossing to 2H:1V slopes through the crossing before transitioning to approximately 2H:1V backslopes with a roadside ditch line east of the crossing.

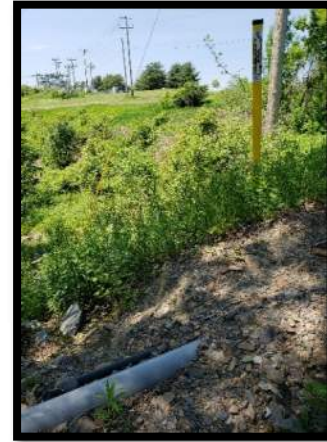
Underground Utilities
at Crossing

During a sight visit by Hoyle, Tanner, underground utilities – gas and telecom – were observed near the surface at the temporary bridge crossing running parallel to the southern edge of pavement. From discussions with the City and Town there is no water main or sewer crossing between the City/Town at this location. A South Burlington stormwater line discharges on the south side of Kimball Avenue near the existing catch basin inlet approximately 300-ft west of the crossing.

Based on our conceptual design we have identified at least two utility poles that may need to be relocated to install the new structure and typical section. These are large poles with many utility lines on them, further coordination will be required during preliminary design to evaluation options for the path design and structure excavation once topographic survey is completed. All alternatives in this study have similar impacts and associated costs to buried and overhead utilities.

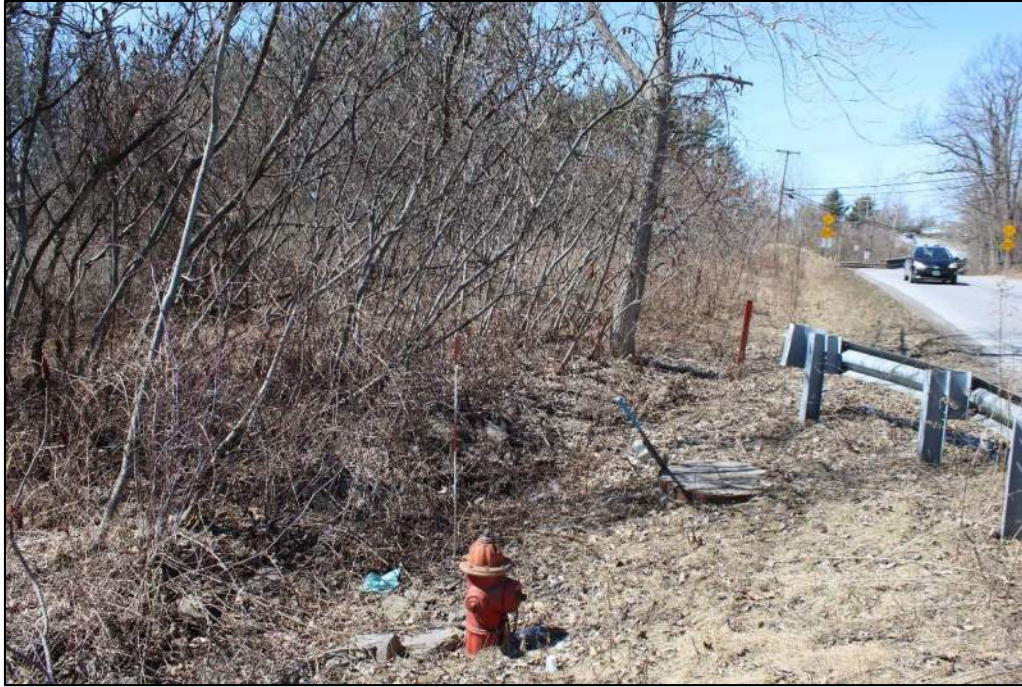
Photo 4. Southeast quadrant of the APE. Note manhole, hydrant and buried telephone line marker. A gas line is also present on this alignment. The area to the left has been filled with gravel for a former parking area. View to the west/northwest.

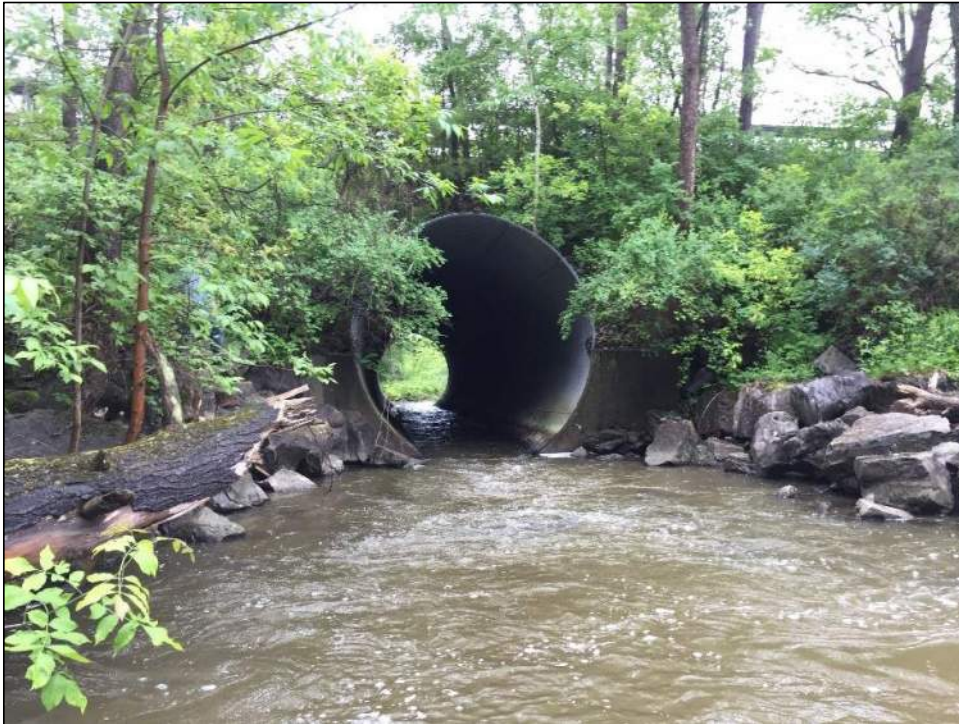
- Existing 15' Diameter Metal Pipe Installed in 1970
- Heavy Corrosion Causes Pipe Buckling & the Road Closure in the Spring of 2017
- 150' Temporary Bridge Installed in August 2017 (VTrans Rental)
- 2009 Muddy Brook Geomorphic Assessment Report (Fitzgerald Environmental)
- Measured Bankfull Width = 32'
- Depth of Road to Streambed = ~30'

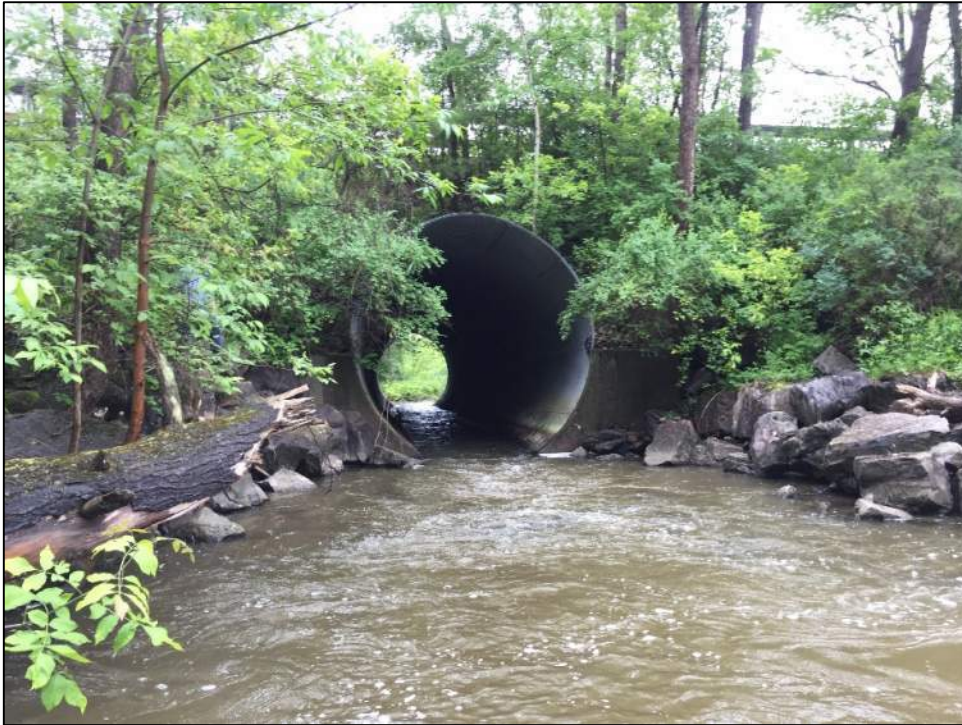
- Existing 15' Diameter Metal Pipe Installed in 1970
- Heavy Corrosion Caused Pipe Buckling & the Road Closure in the Spring of 2017
- 150' Temporary Bridge Installed in August 2017 (VTrans Rental)
- 2009 Muddy Brook Geomorphic Assessment Report (Fitzgerald Environmental)
- Measured Bankfull Width = 32'
- Depth of Road to Streambed = ~30'
