Illicit Discharge Detection & Elimination Program

January 24, 2008

Thomas J. DiPietro Jr., South Burlington Stormwater Superintendent
Horace Shaw, South Burlington GIS Technician

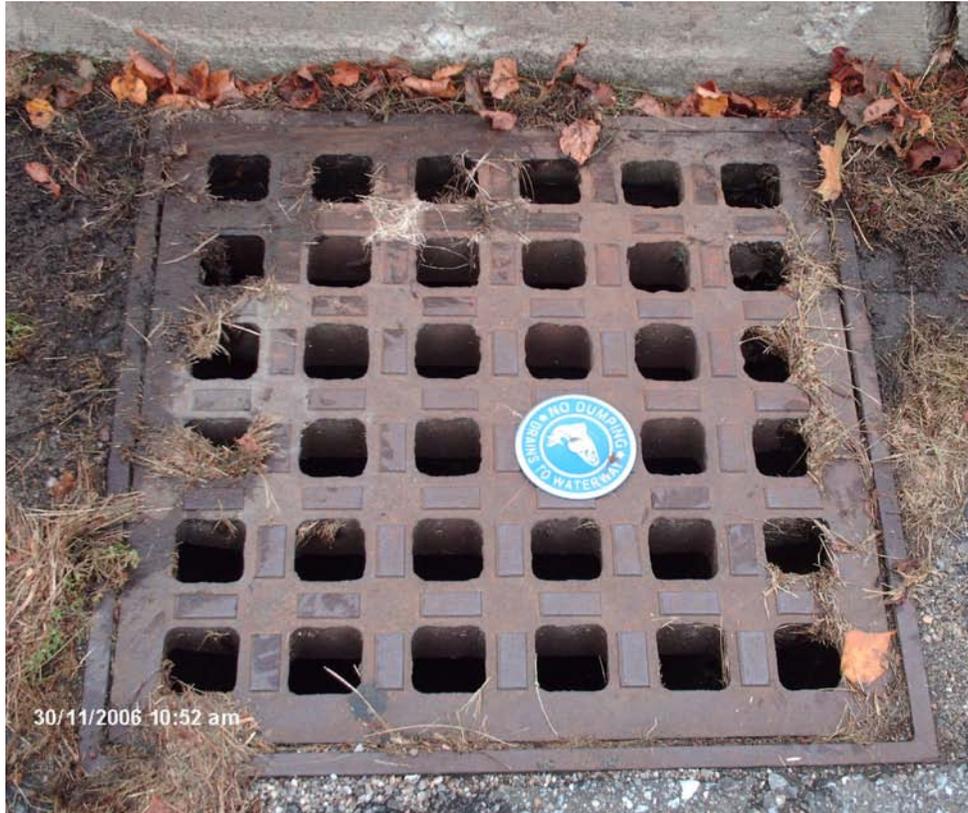
A resident called the Department of Public Works to report that a neighbor had been dumping paint down a storm drain. SWU staff followed up on this claim, but found no clear evidence of this illegal dumping in the storm drain, or at the outfall. SWU staff placed metal “No Dumping” signs on all storm drains in the neighborhood. No additional complaints have been received.

“No Dumping” tag placed on storm drain. The tag indicates that the storm drain leads directly to the stream and waste materials should not be dumped into it.
